Inspection Report

12 Bowden St
Toronto ON M4K 2X2

AmeriSpec Inspection Services Toronto East

**Blair White, CEA, Certified Home Inspector
6A-170 The Donway W.,
Ste #1402
Toronto ON M3C2E8**

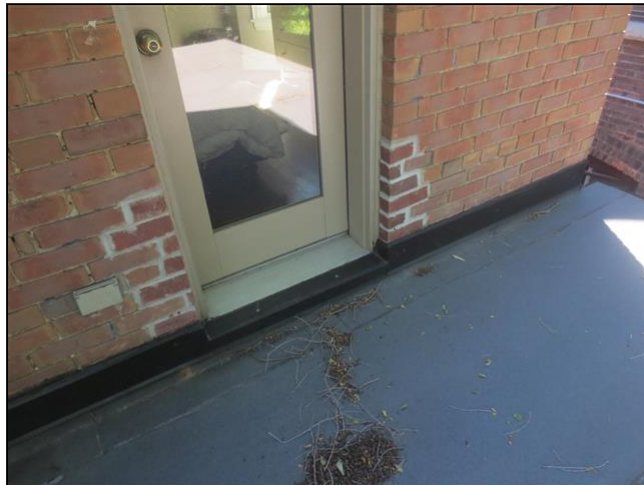
1.5 Item 1(Picture)

1.5 Doors appear to be in serviceable condition.

Prior repairs are evident at the rear upper door to the brick near the bottom. Repairs appear to be serviceable.

Exterior door at upper rear bedroom opens to the flat roof at the rear. If children are present in the home we strongly recommend additional security for this door as there are no railings at the flat roof. Keep locked for safety.

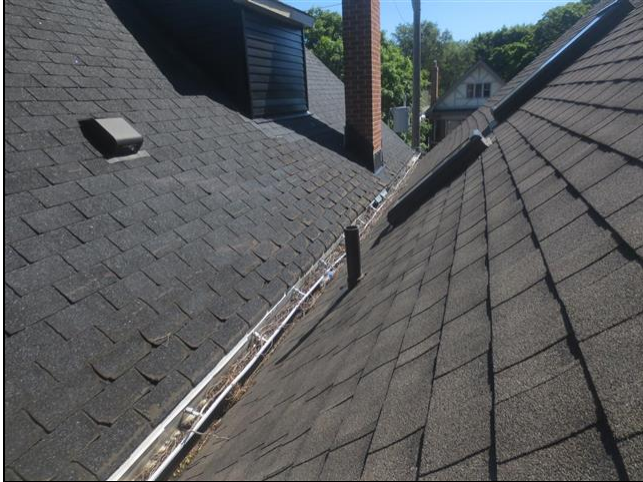
1.6 Item 1(Picture)

1.6 (1) Debris blocked eavestroughs observed at right side of the upper roof, suggest cleaning gutters and downspouts, which should be a regular part of maintenance (Spring and Fall) as it appears the gutters of this home and the neighboring side are very close/overlapping in some areas.

Leafguards are installed at the eavestroughs at the upper and lower roof as observed.

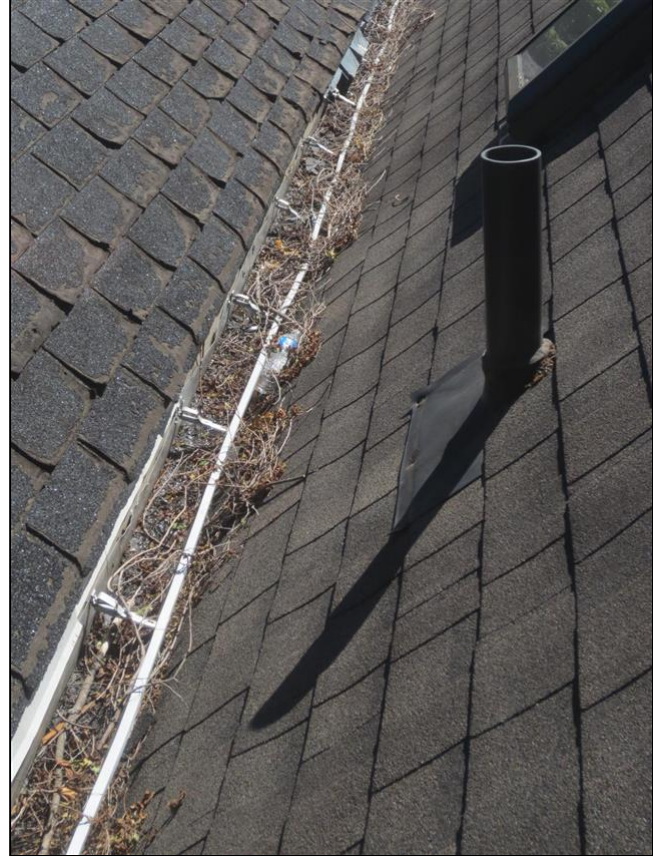
1.6 Item 2(Picture)

1.6 (2) Suggest leaves and debris be cleaned from gutters at the right side of the upper roof - it's imperative to keep the valley between the 2 houses clear of debris to allow for proper drainage in this area.

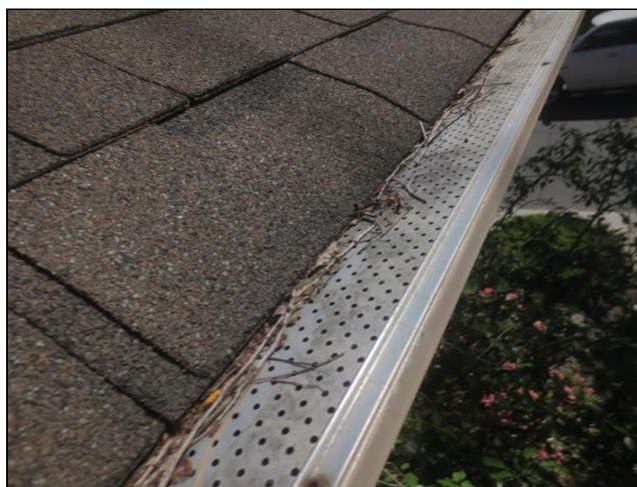
2.0 Item 1(Picture)

2.0 (1) Shingles appears to be in serviceable condition.

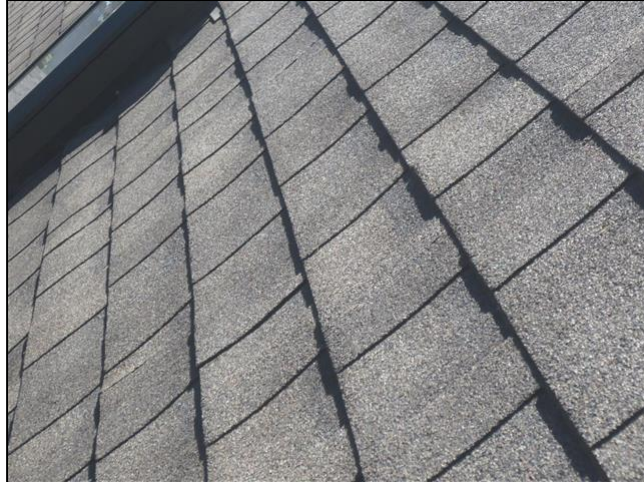
2.0 Item 2(Picture)

2.0 (3) Roof shows normal wear for its age and type. No damaged, deteriorated, or missing roofing materials were observed; it appears to be in serviceable condition.

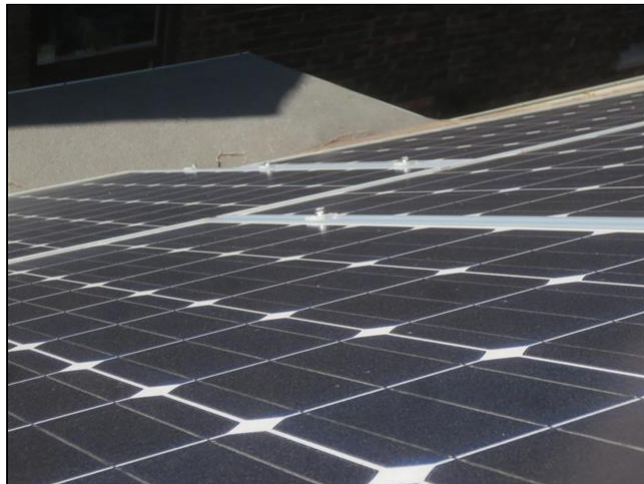
2.3 Item 1(Picture)

2.3 Solar panels are affixed to the upper roof south slope. The panels are out of scope for this inspection. We recommend consulting with sellers for more information on the setup of the solar panels and usage/storage of power.

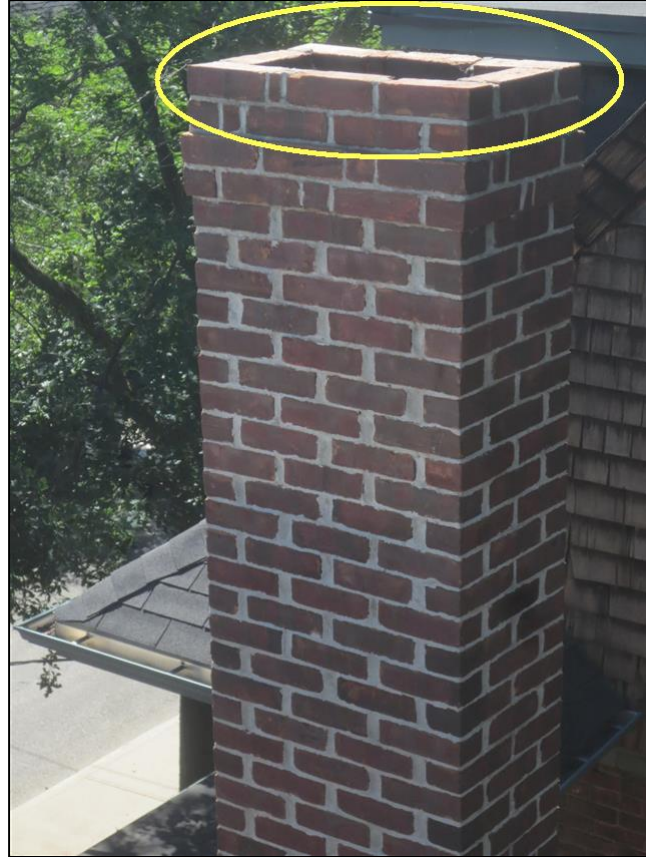
3.3 Item 1(Picture)

3.3 The chimney has no spark arrester/ rain cap installed at the top of the chimney flue. We suggest installing as a safety measure and to reduce the possibility for pest intrusion and water infiltration into the chimney.

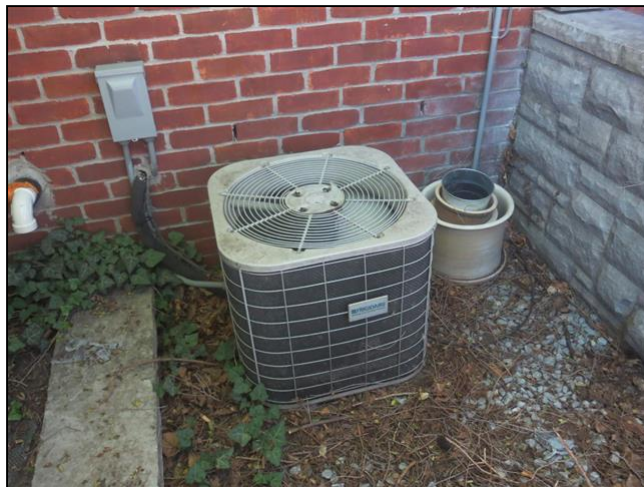
4.0 Item 1(Picture)

4.0 Efficiency and load calculations are beyond the scope of this inspection and expressly omitted from this report. If a detailed inspection is desired, a licensed heating contractor should be consulted prior to closing to ensure proper operation of this unit. It is recommended that your ducts be professionally cleaned on a regular basis.

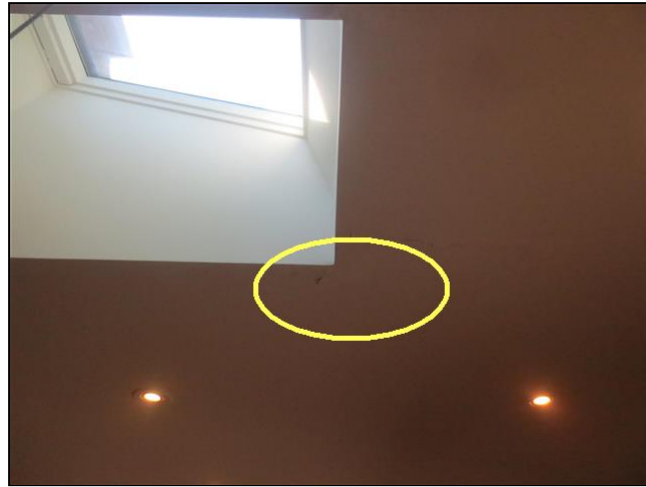
7.5 Item 1(Picture)

7.5 (1) Water damage observed at the skylight in kitchen area above island which, according to the sellers occurred during the recent ice storm. We checked the area around the skylight at the roof and its flashings and were unable to observe any obvious openings or breaks/gaps in the flashings. The type of storm we experienced at that time caused damages in numerous homes which hadn't previously had issues or damages caused by normal weather events. As such, we recommend patching the drywall and monitoring over the medium to long term as well as after significant storms.

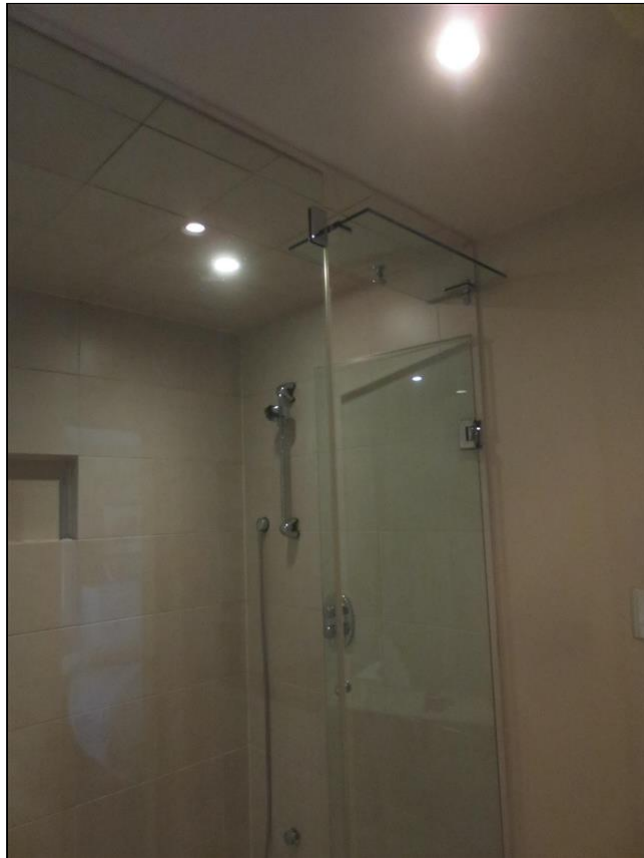
8.9.A Item 1(Picture)

8.9.A Tempered safety glass installed for safety.

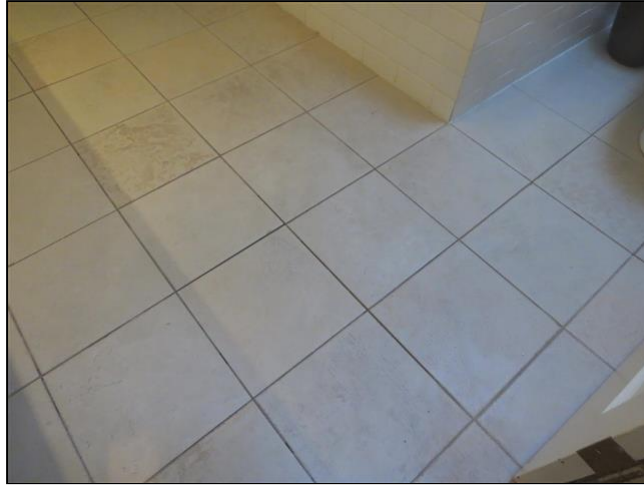
8.0.B Item 1(Picture)

8.0.B Loose as well as cracked tile(s) observed. Appears to be primarily a cosmetic concern; recommend corrections as needed.

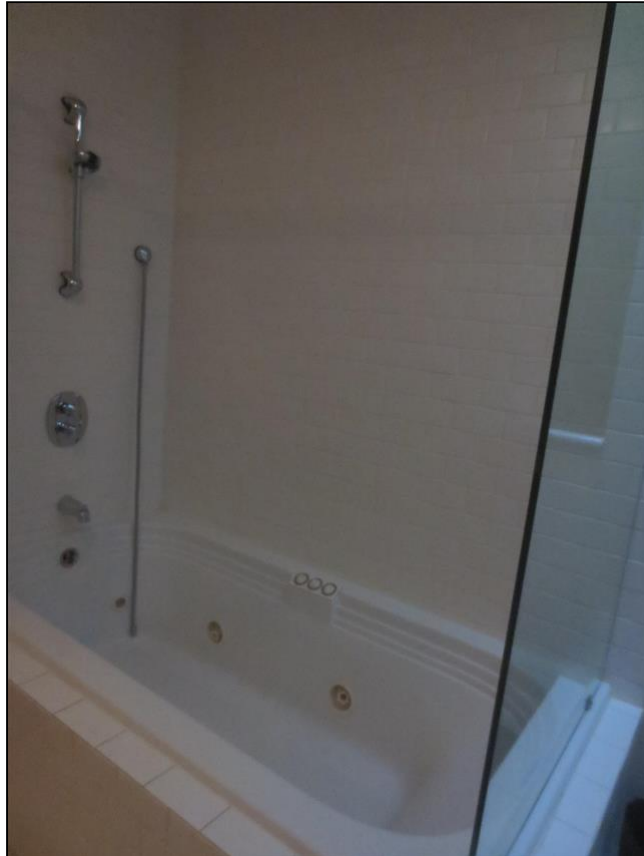
8.8.B Item 1(Picture)

8.8.B A whirlpool tub is present. Tub was filled to a level above the water jets and operated to check intake and jets. Pump and supply lines were not completely accessible. The items tested appeared to be in serviceable condition. If a more detailed report is desired, the client is advised to consult a qualified plumber.

(Note: Unable to access motor and electrical connections as no access hatch provided below tub. Limited review based on this.)

Missing overflow plate as well as stopper is broken in tub. Recommend minor repairs.

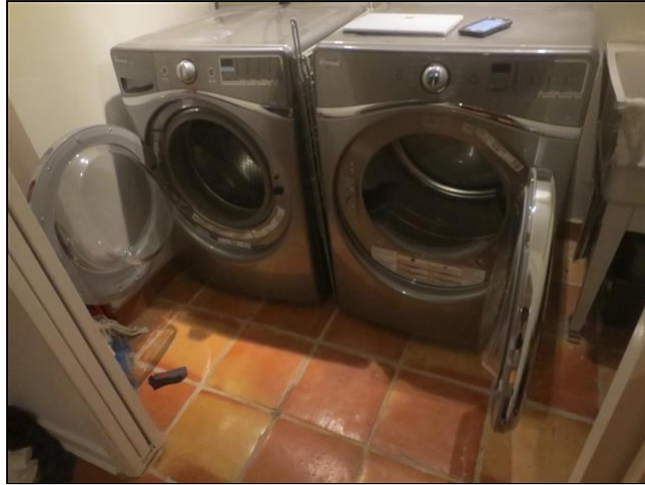
9.7 Item 1(Picture)

9.7 Washer was not operated at the time of inspection. According to seller the unit is in operating condition.

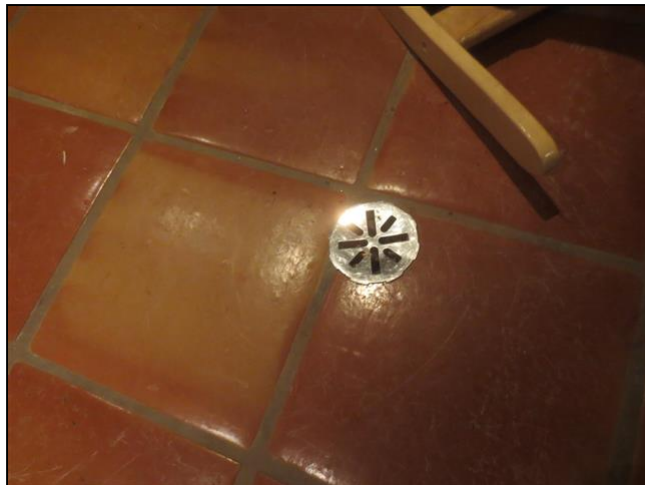
9.10 Item 1(Picture)

9.10 Floor drains observed which appear to be in serviceable condition.

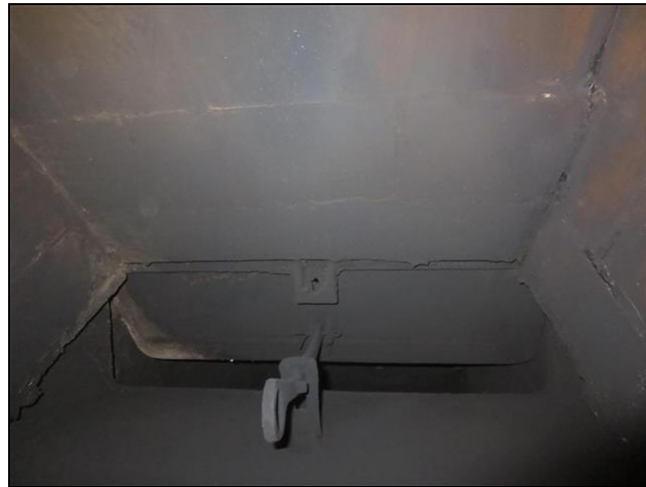
11.7 Item 1(Picture)

11.7 A wood burning appliance is noted. A detailed assessment of the adequacy of the installation, clearances to combustible materials and shielding was not completed as part of the home inspection. We recommend consulting with a Wood Energy Transfer Technology (WETT) certified inspector or contractor for further assessment to ensure safe and proper installation prior to close. Please refer to the Ask the Inspector article regarding Wood Burning Systems or contact us for further information. Given that more recently home insurance companies have very restrictive policies regarding the presence of wood stoves in homes, we recommend consulting with your insurance company to obtain policy information regarding wood burning appliances and verify proper installation in accordance with their requirements. Please refer to the Ask the Inspector article regarding Wood Burning Systems for further information found at www.amerispec.ca

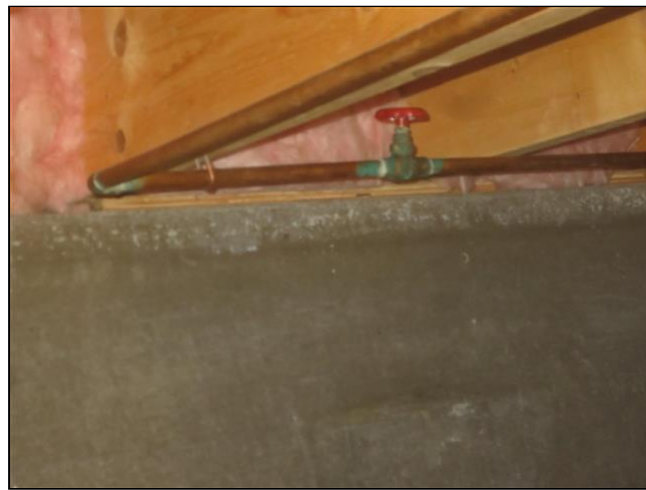
14.20 Item 1(Picture)

14.20 Floor drain was observed at the basement.

Shutoff for rear exterior faucet is in crawlspace as observed.

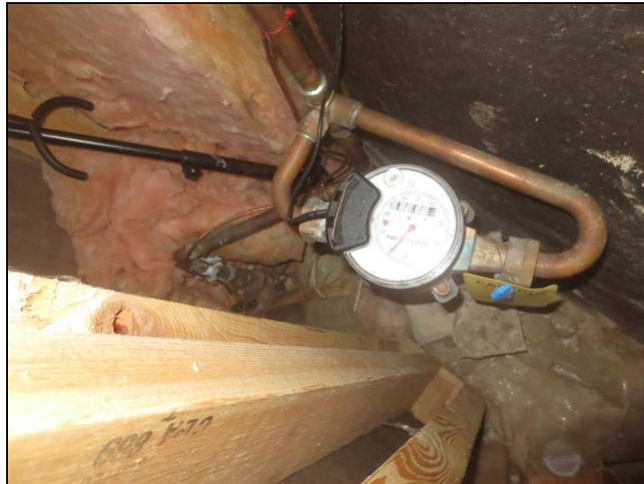
15.0 Item 1(Picture)

15.0 Located near main electrical panel closet.

Limited access. Recommend installing access panel for easier access to main shutoff.

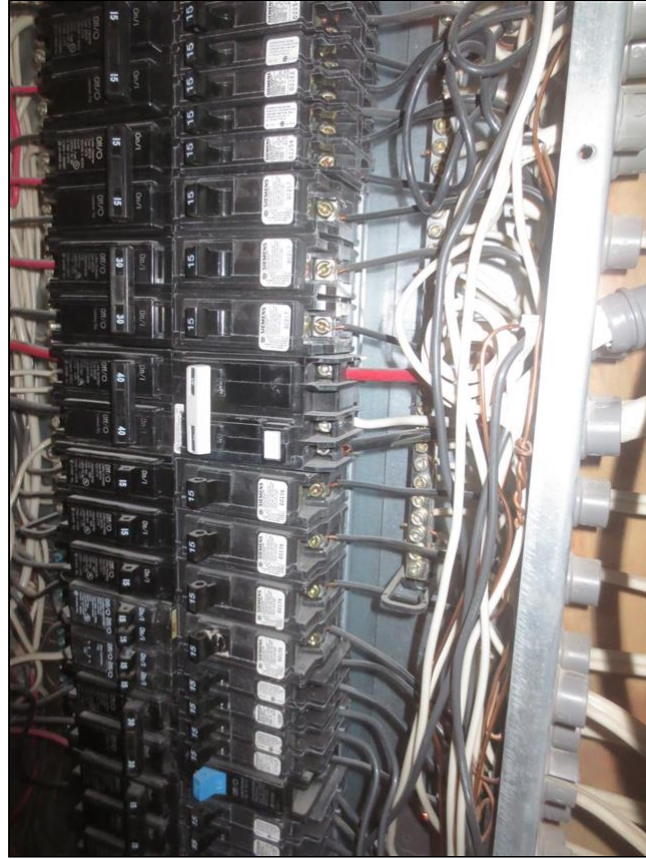
16.2 Item 1(Picture)

16.2 Home appears to be fully upgraded to copper, 3-wire, grounded, romex wiring.

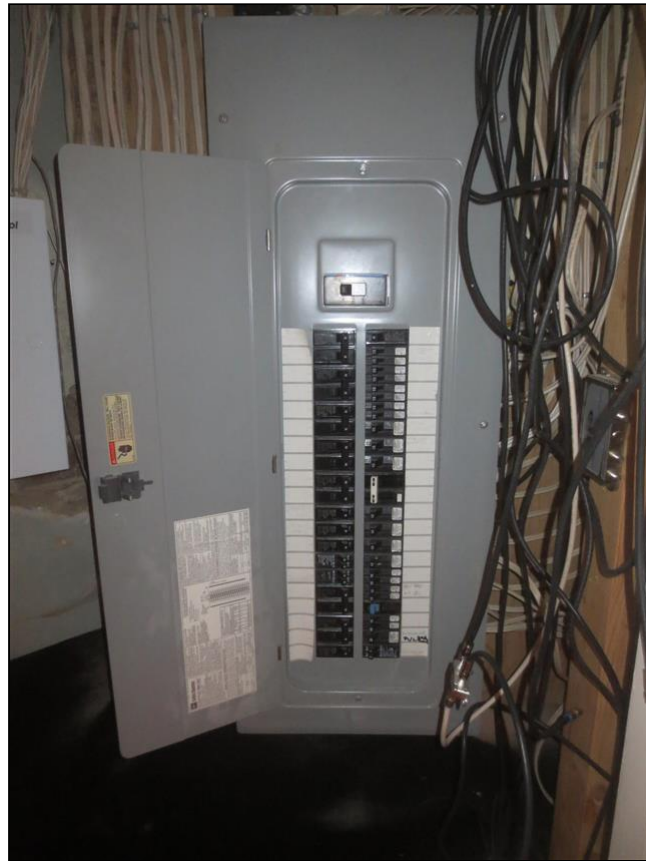
16.5 Item 1(Picture)

- **Main Panel appears to be in serviceable condition. Copper, 3-wire, grounded circuits observed in the home which appears to be fully updated.**
- **Arc- Fault Circuit Interrupters (AFCI) may not have been required when the home was built. Suggest client consider upgrading with AFCI's at all receptacles bedrooms to enhance safety. Arc- Fault Circuit Interrupters contain solid state circuitry that will recognize the unique voltage and current wave form combinations that are the "signature" of an electrical arc, and they open the circuit when arcing occurs. Upgrades should be performed by a licensed electrician.**

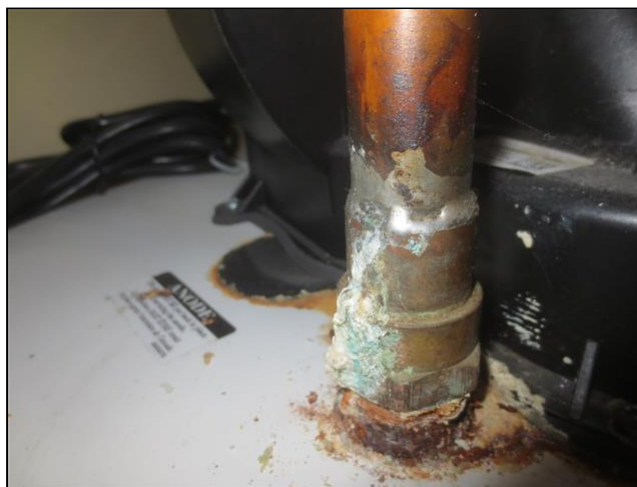
17.3 Item 1(Picture)

17.3 (1) Giant, 2015, 50 Gallon

Pinhole leak on supply pipe. Very small amount of water leaking however is causing some corrosion at the connection. Monitor over the short term and have a licence HVAC technician review at next maintenance of furnace to include water heater maintenance.

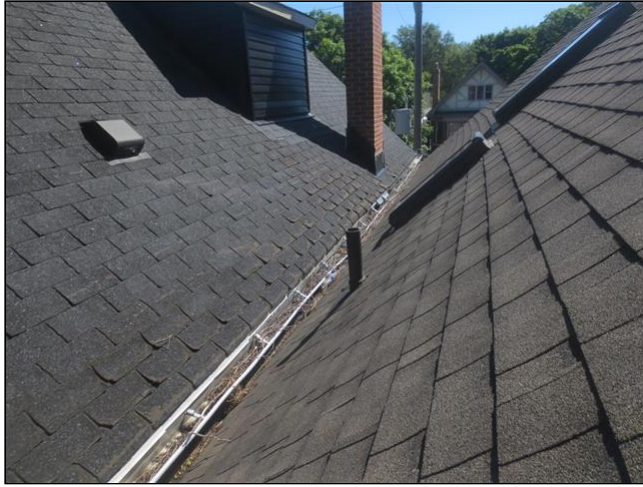
1.6 Item 1(Picture)

(1) **Debris blocked eavestroughs observed at right side of the upper roof, suggest cleaning gutters and downspouts, which should be a regular part of maintenance (Spring and Fall) as it appears the gutters of this home and the neighboring side are very close/overlapping in some areas.**

Leafguards are installed at the eavestroughs at the upper and lower roof as observed.
